# Macroinvertebrates

A Technical Report to inform the  
Healthy Waterways Strategy Mid-term Review

Melbourne Water (2023), *Macroinvertebrates: A Technical Report to inform the Healthy Waterways Strategy Mid-term Review*. Melbourne Water, Docklands, Victoria, Australia.

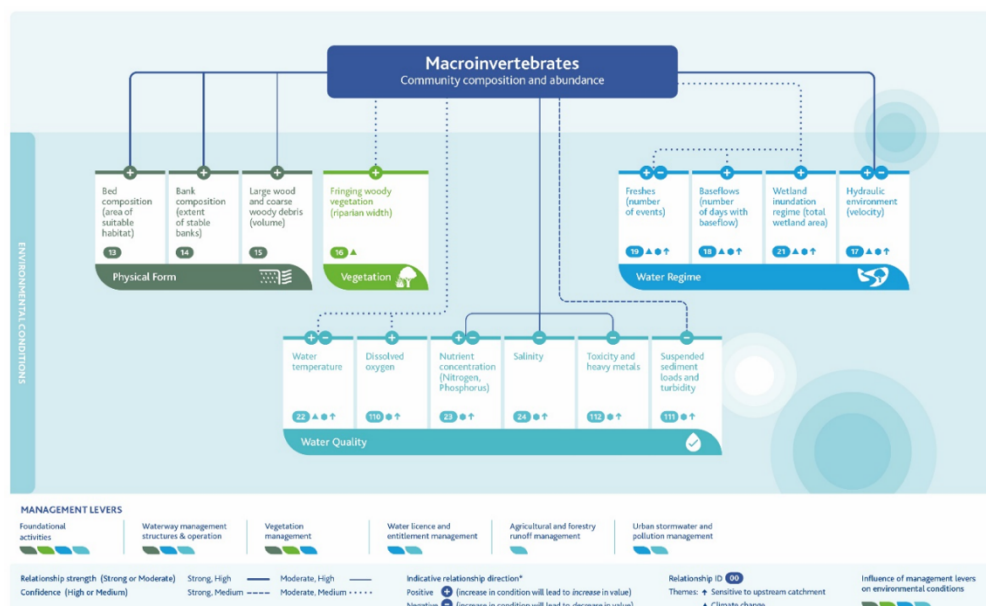
Figure 1. Static conceptual model of showing the connection between environmental conditions and macroinvertebrates community composition and abundance.

To help understand what is driving particular trends observed in the site monitoring data, we draw on the conceptual models which were refined during the development of the HWS (Figure 1).

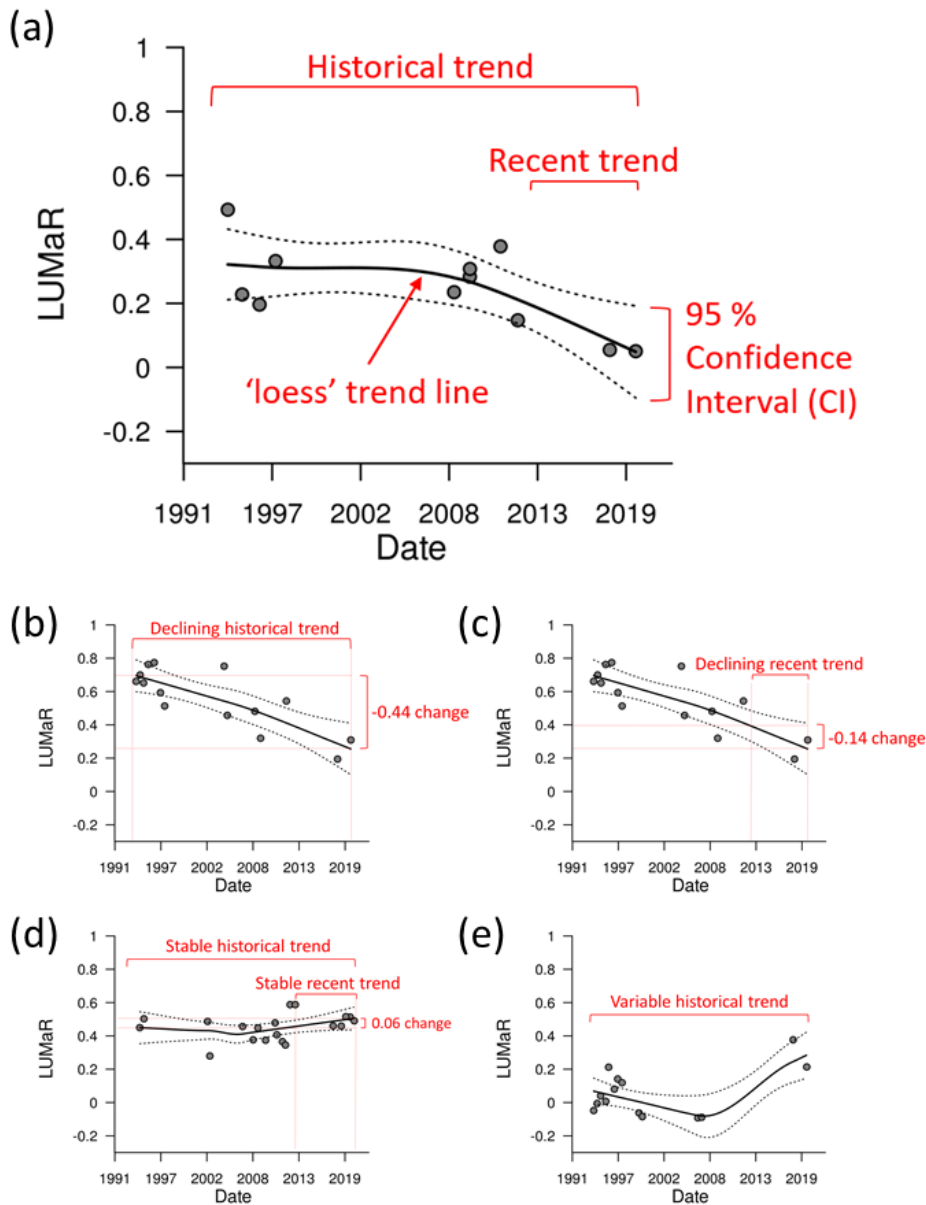
Figure 2. Illustration of how we assessed non-linear trend lines to determine sites requiring further reporting. Plot (a) shows the 'loess' trend line and its 95% confidence interval (CI) as well as the timeframe considered for historical and recent trends; (b) shows a declining historical trend; (c) shows a declining recent trend; (d) shows stable historical and recent trends; (e) shows a variable historical trend.

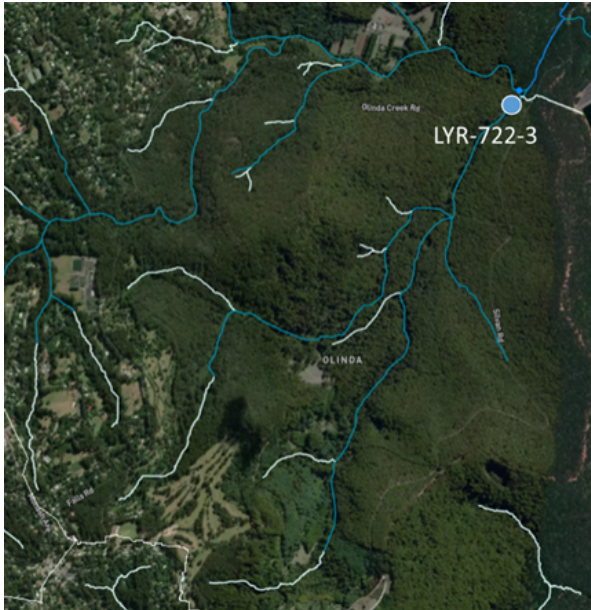
Figure 11. Aerial image of location of LYR-722-3 Lyrebird Gully Creek macroinvertebrate sampling location and its upstream catchment area. Headwaters are shown in white, tributaries in teal.

Lyrebird Gully Creek is located downstream of Olinda Road, Olinda, and was first sampled for macroinvertebrates in 1994. It is located in a forested catchment of the Dandenong Ranges, though there is some urbanisation upstream of this site. The creek is a tributary of Olinda Creek and is not impacted by the Silvan Reservoir. This location is known habitat for Dandenong Ranges Amphipod, listed as threatened under the Flora and Fauna Guarantee Act (1988).

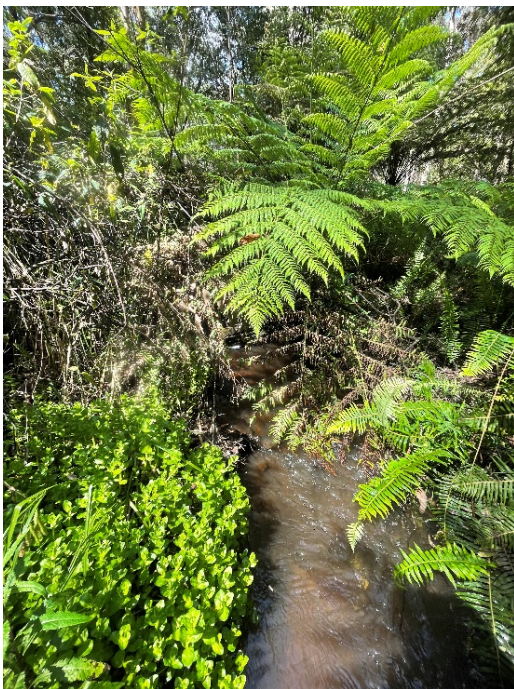
Photo 1. Photo of LYR-722-3: Lyrebird Gully Creek (Olinda Creek subcatchment)/

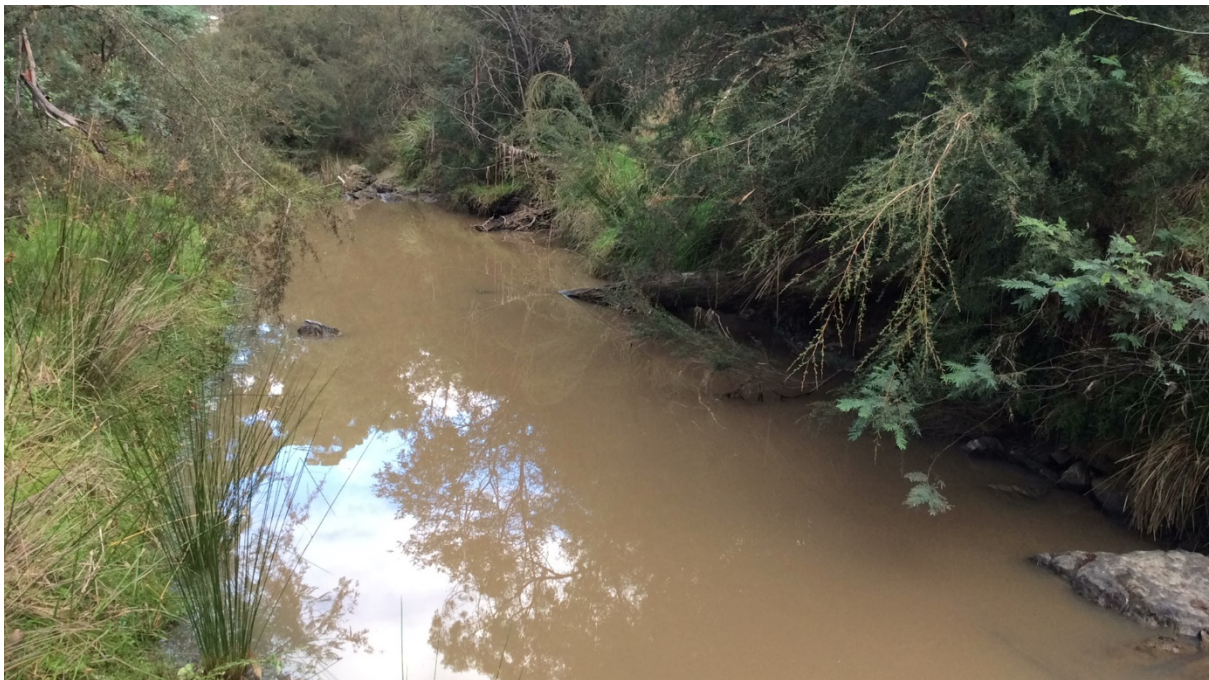
Photo 2. Photo of DIY-5232-7: Diamond Creek (Tributary of Yarra) (Diamond Creek (Rural) sub-catchment).

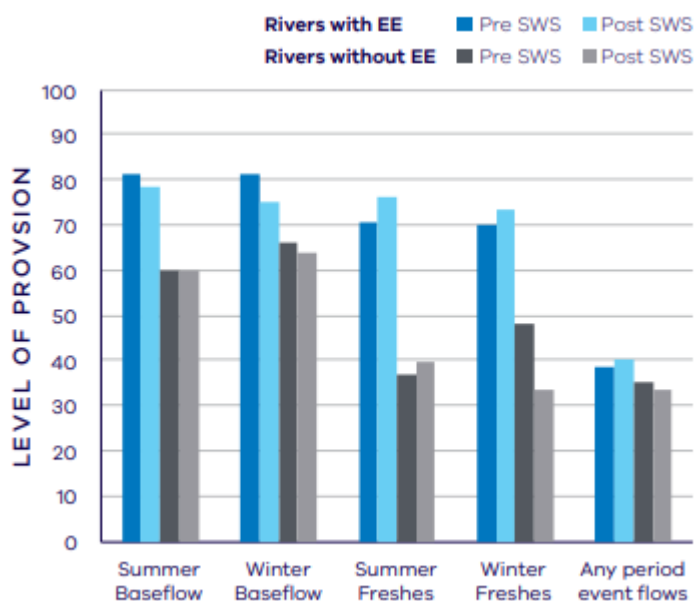
Figure 17. Average change in provision of ecologically important flow components in rivers with environmental entitlements (EE) and without pre SWS (1975 – 2006) and post SWS (2007 – 2018) (graph sourced from LTWRA). Y axis is % provision of the flow component.

The Long-term Water Resource Assessment (LTWRA) (Victorian Government, 2020) mentions that management of waterways that do not have environmental entitlements, such as the Diamond Creek, have actually declined in their provision of environmental flow components over time, even with the protections of the Central Region Sustainable Water Strategy (CRSWS) and the Diamond Creek Local Management Plan (2016) in place (Figure 17).

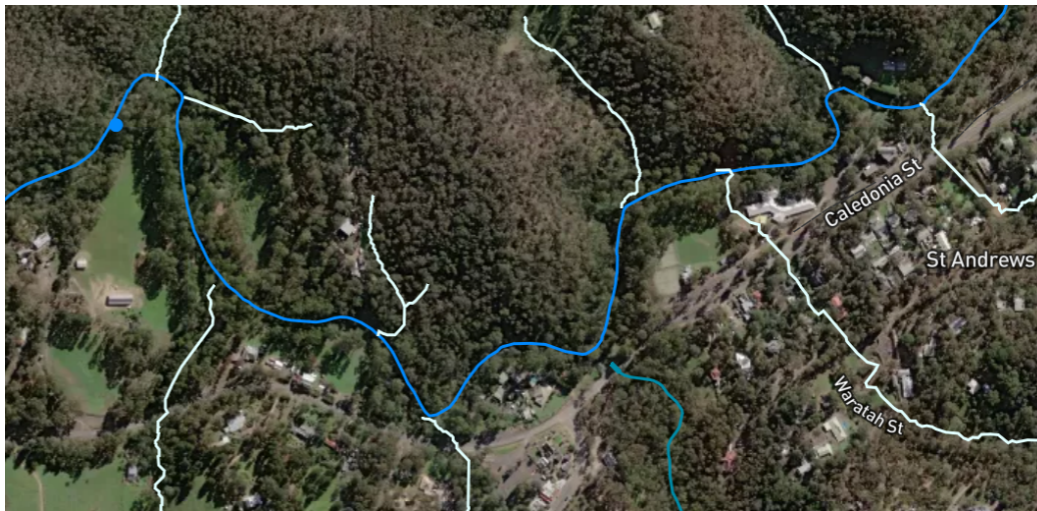
Vegetation quality along this reach is medium (i.e. level 3 vegetation vision score). There has been no change to the extent of vegetation with attenuated forest cover along this reach at 69.8% in 2006 and 2016.

*Figure 18. Macroinvertebrate monitoring site location and upstream reach (aerial image is from OpenStreetMap 2021).*

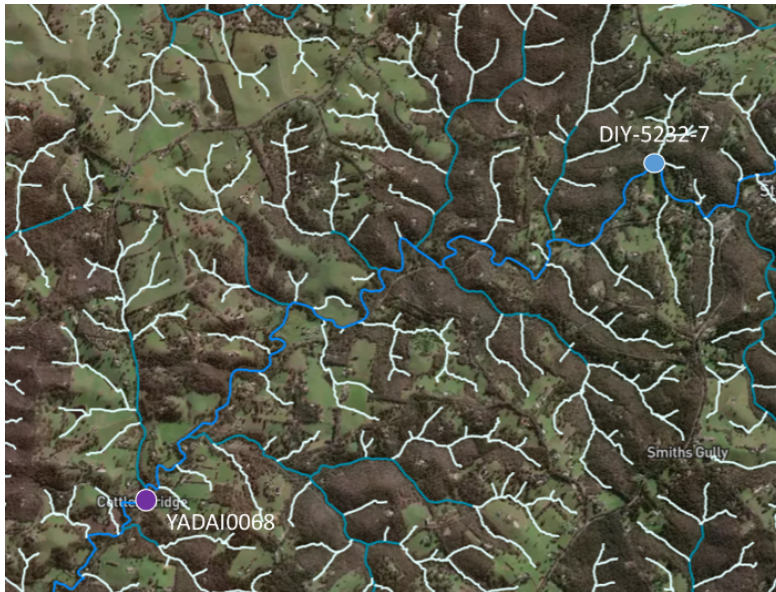
There are no long-term water quality monitoring location in the immediate vicinity, but there is a location downstream in Cottles Bridge (Figure 19).

Figure 19. Map showing relative location of Macroinvertebrate site DIY-5232-7 (in blue) and water quality monitoring site YADIA0068 (in purple).

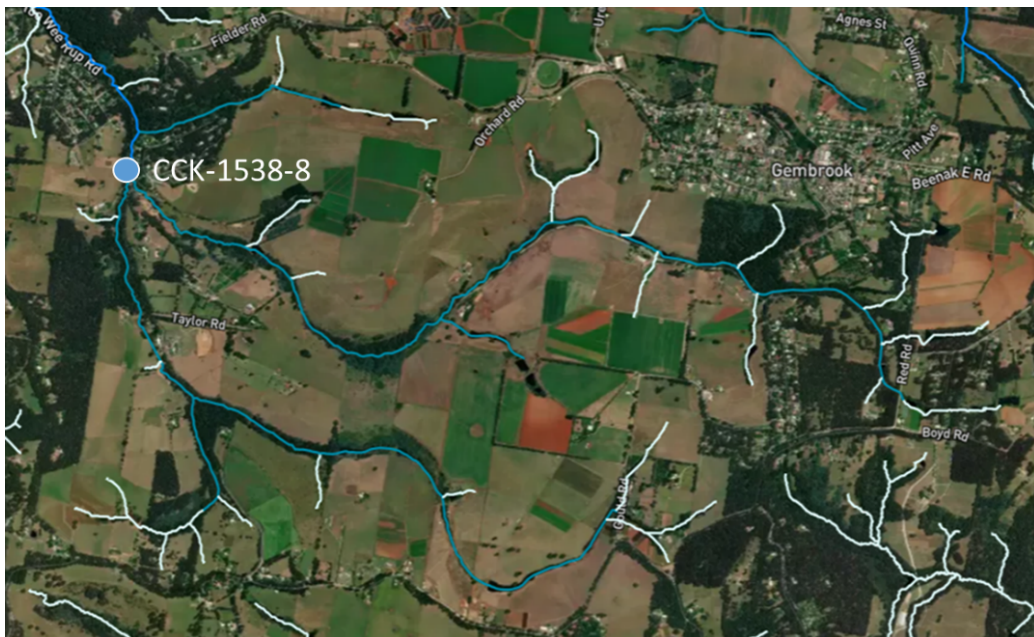
Cockatoo Creek downstream of Brisbane Road bridge in Cockatoo was first sampled for macroinvertebrates in 1994. Its catchment is predominately rural (Figure 22).

Figure 22. Aerial image of location of CCK-1538-8 Cockatoo Creek macroinvertebrate sampling location and its upstream catchment area. Headwaters are shown in white, tributaries in teal.

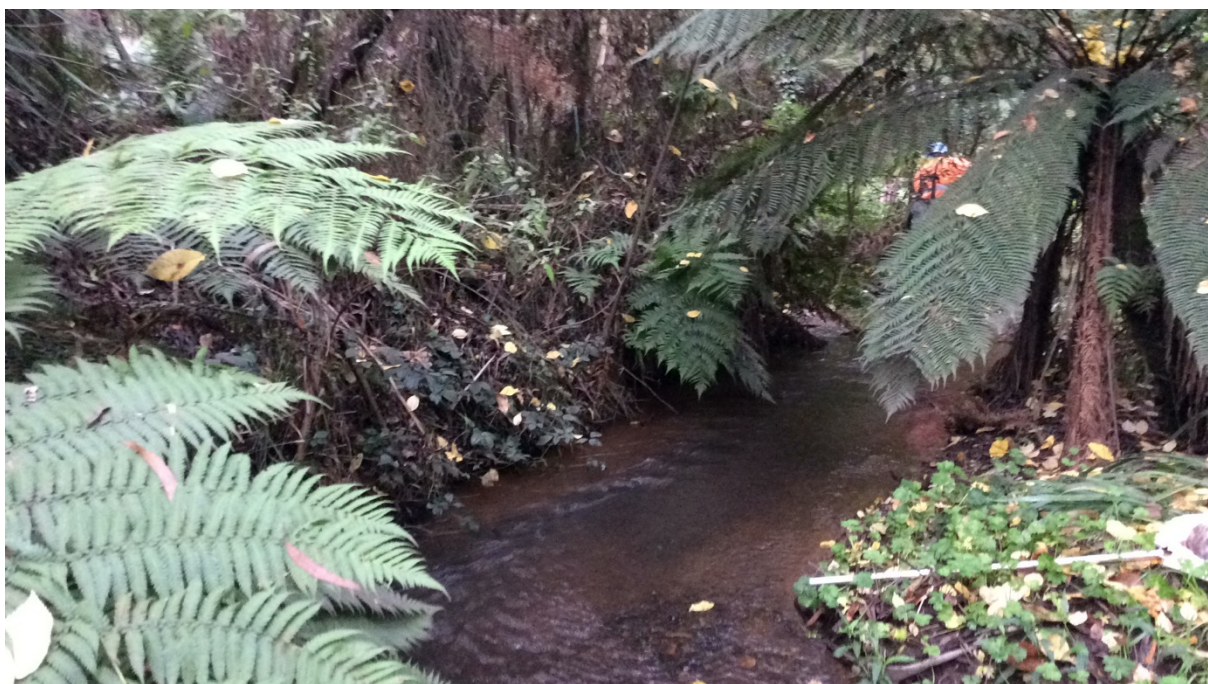
Photo 3. Photo of CCK-1538-8 (Woori Yallock Creek sub-catchment).

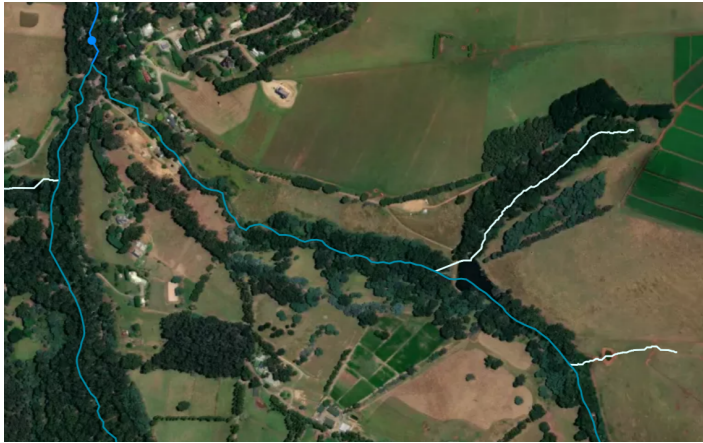
Vegetation quality is rated at low (vegetation visions score of 2) along Cockatoo Creek and medium along Gembrook Creek (level 3). Time-lapse imagery over the period 1984-2020 (data not shown) does not show a detectable change in either land clearing or revegetation of the riparian zone over this time period. Attenuated forest cover was 46% in 2006 and 46.5% in 2016.

Figure 26. Macroinvertebrate monitoring site location and upstream reach (aerial image is from OpenStreetMap 2021).

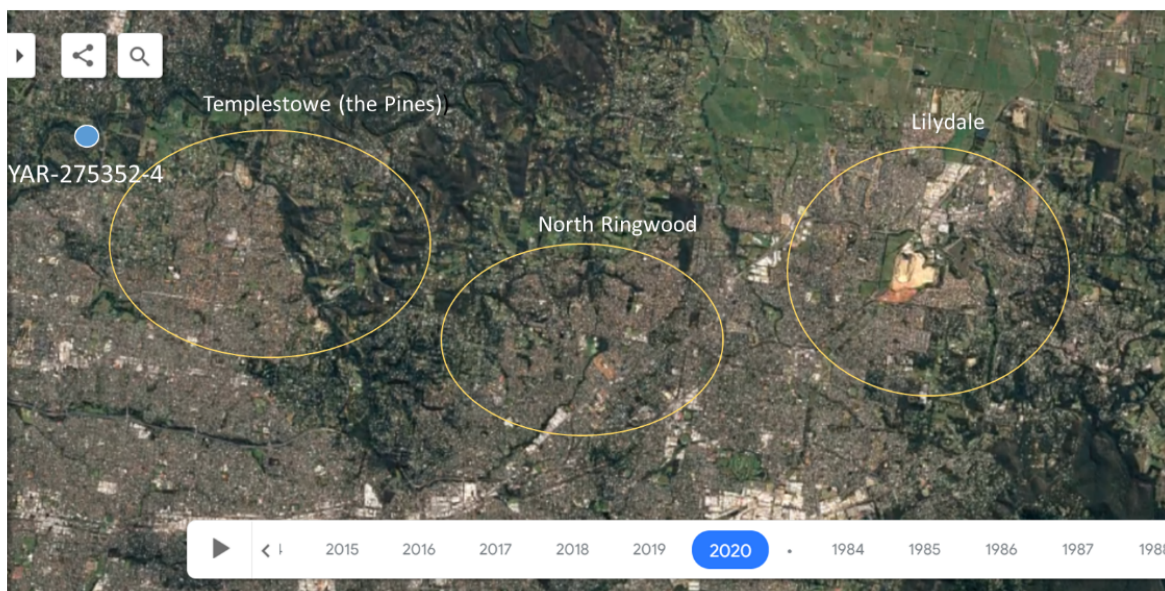
Figure 30. Catchment area upstream of YAR-275352-4 Yarra River at Fitzsimons Lane depicting change in urbanisation in Templestowe, North Ringwood and Lilydale between 1984 and 2020.

The area immediately upstream of Fitzsimons Lane has undergone significant urbanisation since the late 80's, which has likely contributed to macroinvertebrate decline. The impact of urbanisation on macroinvertebrate communities is well documented (Walsh, et al. 2001). The images in Figure 30 Figure 30. Catchment area upstream of YAR-275352-4 Yarra River at Fitzsimons Lane depicting change in urbanisation n in Templestowe, North Ringwood and Lilydale between 1984 and 2020.show a time series of aerial images that depict the changes in urbanisation over time.

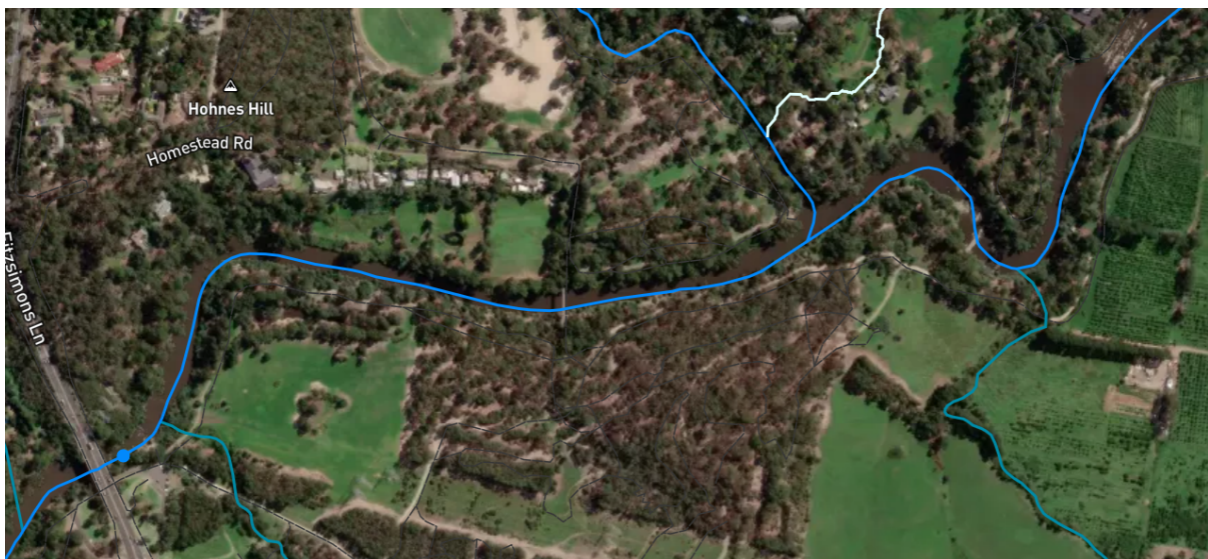
Vegetation is rated as medium (vegetation vision level 3) along this reach (Figure 32). There has been no change in vegetation extent between 2006 and 2016, with attenuated forest cover at 52% along this reach.

Figure 32. Macroinvertebrate monitoring site location (in blue) and upstream reach (aerial image is from OpenStreetMap 2021).

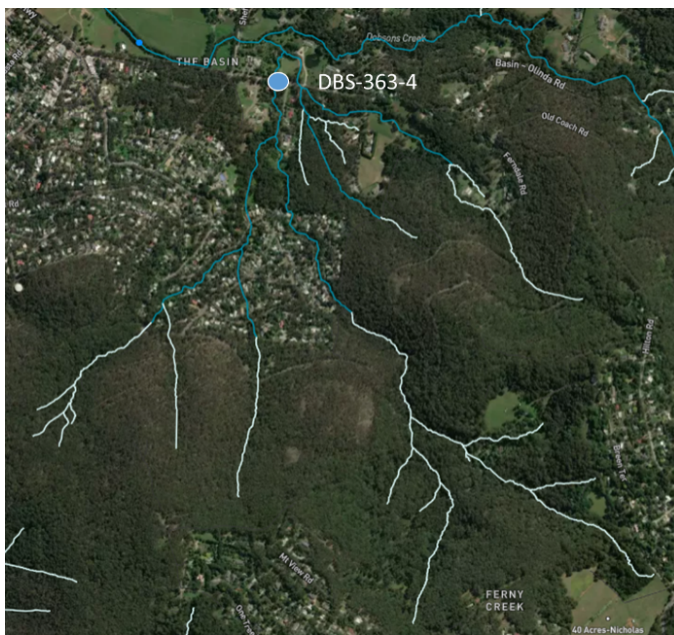
Dobsons Creek is located upstream of Basin-Olinda Road in the Dandenong Creek Upper sub-catchment and has been the focal area for some significant stormwater intervention works. The sub-catchment is considered to be urban with forested headwaters. The location of the site is shown in Figure 33.

*Figure 33. Aerial image of location of DBS-363-4 Dobsons Creek macroinvertebrate sampling location and its upstream catchment area. Headwaters are shown in white, tributaries in teal.*

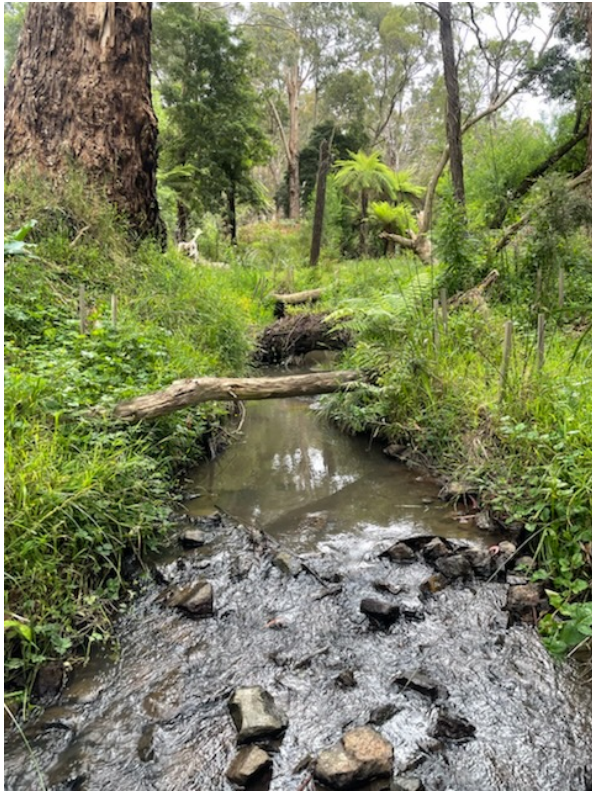
Photo 5. DBD-363-4 (Dandenong Creek Upper sub-catchment).

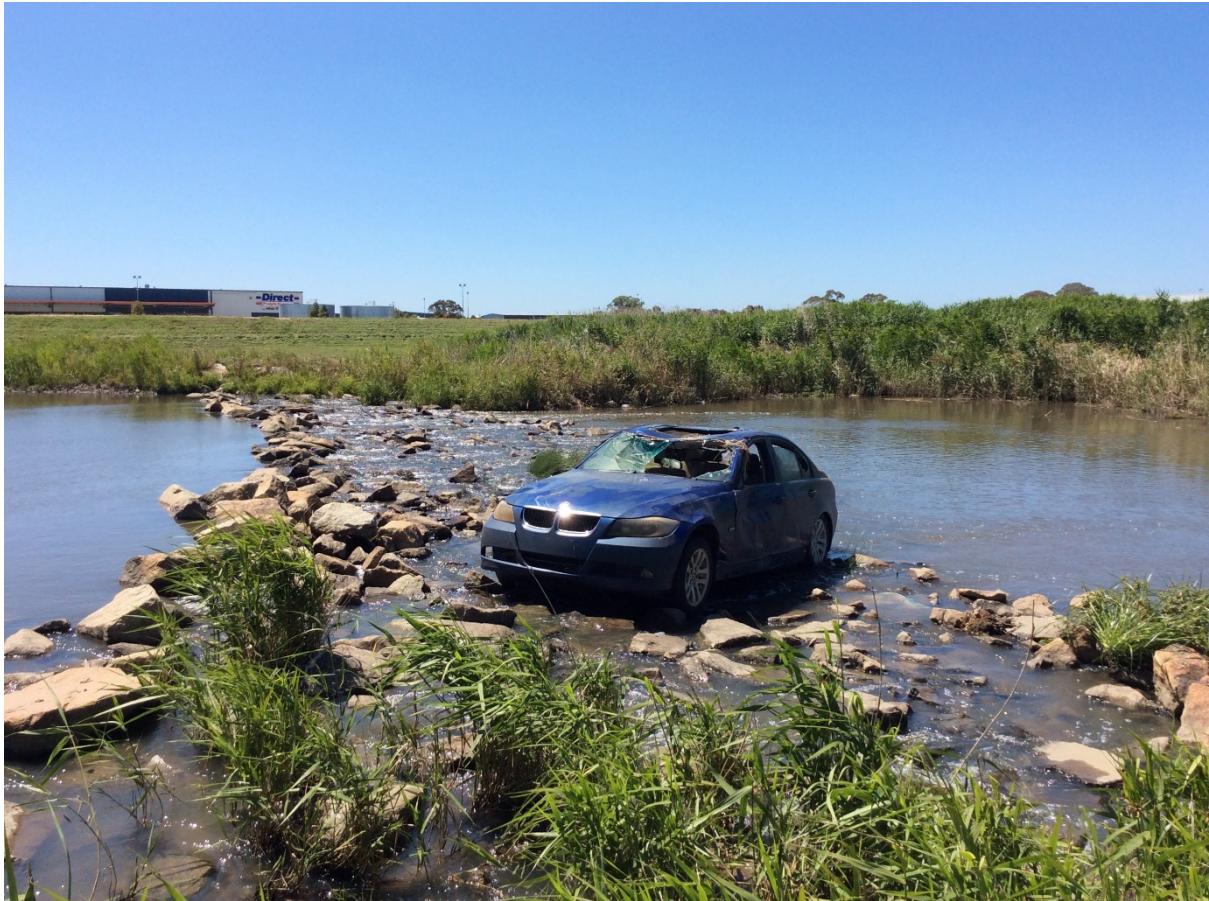
Photo 7. DNG-31881-3 (Dandenong Creek Lower sub-catchment).

Dandenong Creek at Brady Road (Endeavour Hills) (Photo 6) is situated in the Dandenong Creek Middle sub-catchment and was first sampled for macroinvertebrates in December 1993. Dandenong Creek at Pillars Crossing (Dandenong South) (Photo 7) is situated in the Dandenong Creek Lower sub-catchment and was first sampled for macroinvertebrates in June 1994. Both sub-catchments are highly urbanised and are located downstream of large artificial stormwater wetlands.

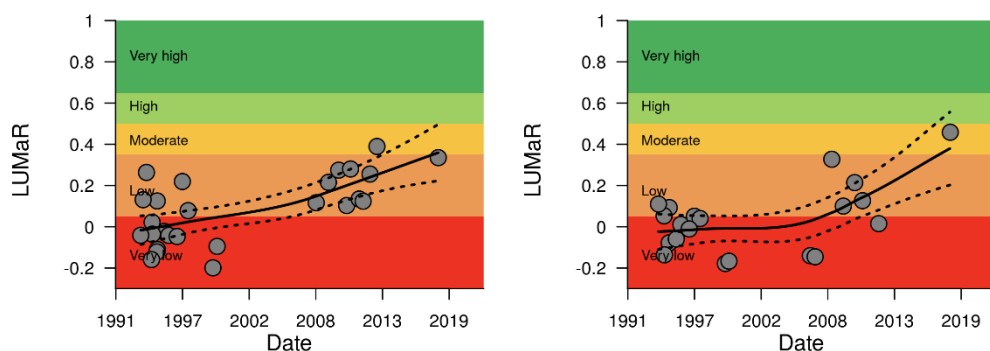
Figure 36. The LUMaR index values (grey dots), trend line (solid line), and 95 % confidence intervals of the trend line (dashed line) for Dandenong Creek DNG-23690-8 (left) and DNG-31881-3 (right).

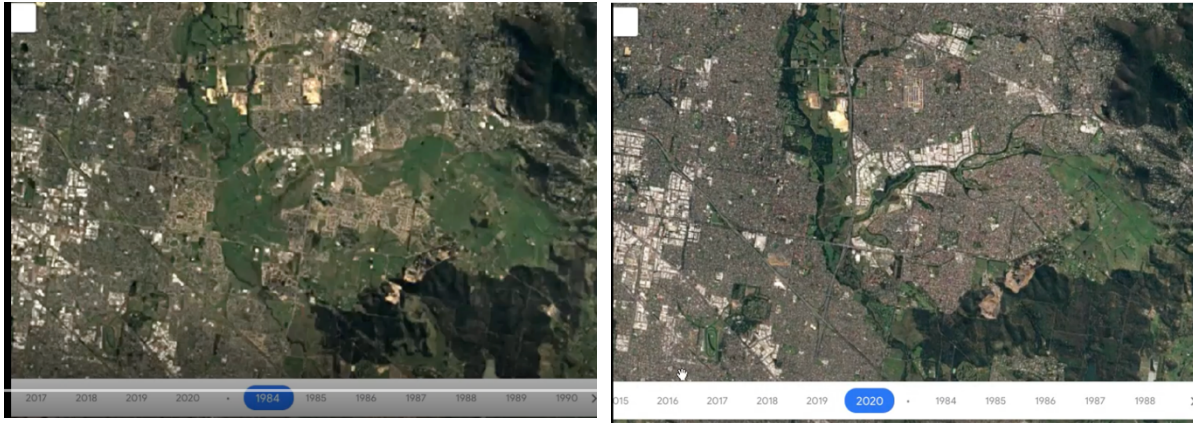
Significant urbanisation occurred across the catchment from the late 80's when many industrial and residential areas expanded and impervious areas increased dramatically. Time-lapse photography of the region of the Dandenong Creek catchment upstream of DNG-23690-8 (an area corresponding to Figure 40) shows the scale of change both in urbanisation and revegetation along the main stem of the Dandenong Creek over the time period 1984 to 2020 (Figure 38).

Figure 38. Photo extract from time lapse movie of a portion of the Dandenong catchment upstream on DNG-23690-8 which shows urbanisation between 1984 and 2020 and riparian restoration and stormwater wetland construction along the main stem of the Dandenong Creek.

Significant revegetation along the main stem of the creek has been undertaken since the 80's, indicating a change from the 60's when this urban waterway was primarily managed for flood protection and vegetation along the banks was considered a hindrance to floodwater discharge. Timelapse photography (Figure 38) depicts the scale of revegetation along the main stem of the Dandenong creek over the time period 1984 to 2020.

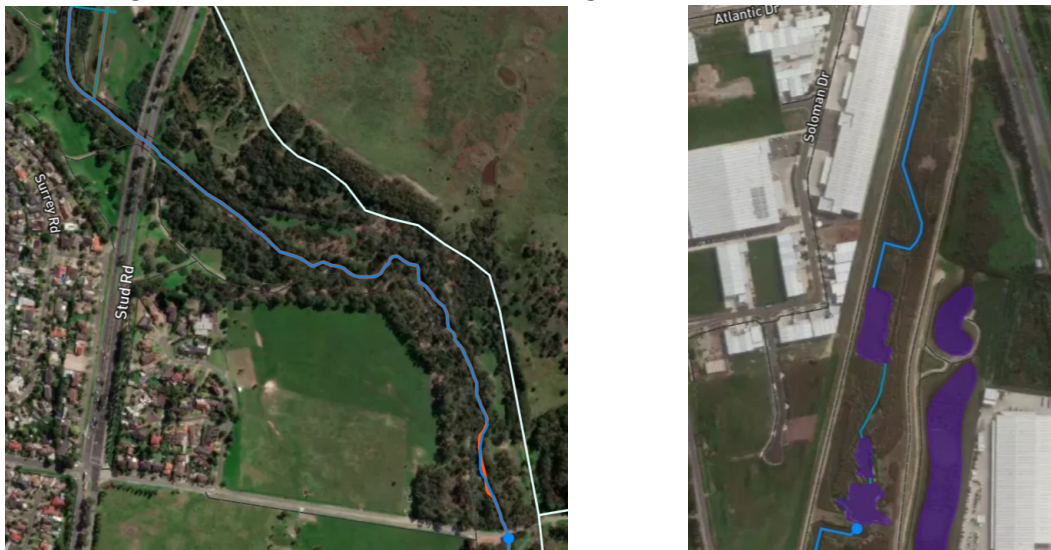
Vegetation quality is rated as low along both reaches (ie vegetation vision score of 2 out of 5). Attenuated forest cover is 48.4% along the middle Dandenong Creek reach and 11% along the lower Dandenong Creek reach. Neither sites have changed between 2006 and 2016.

Figure 39. Macroinvertebrate monitoring sites location and upstream reach - DNG-23690-8 (left) and DNG-31881-3 (right). (aerial image is from OpenStreetMap 2021).

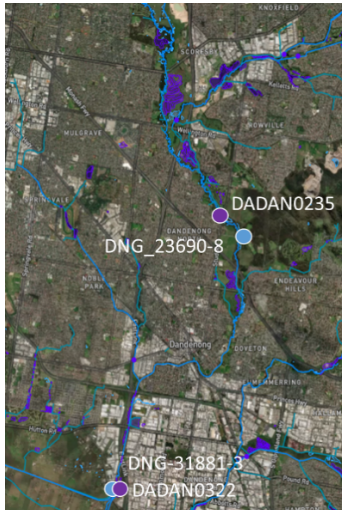
Another long-term water quality monitoring site (DADAN0322 – Dandenong Creek at Pillar’s Crossing (Greens Rd) ) is co-located with the downstream macro monitoring site DNG-31881-3 (Figure 43).

Figure 43. Map of Dandenong Creek catchment area depicting the location of macroinvertebrate and water quality monitoring locations relative to stormwater treatment wetlands.

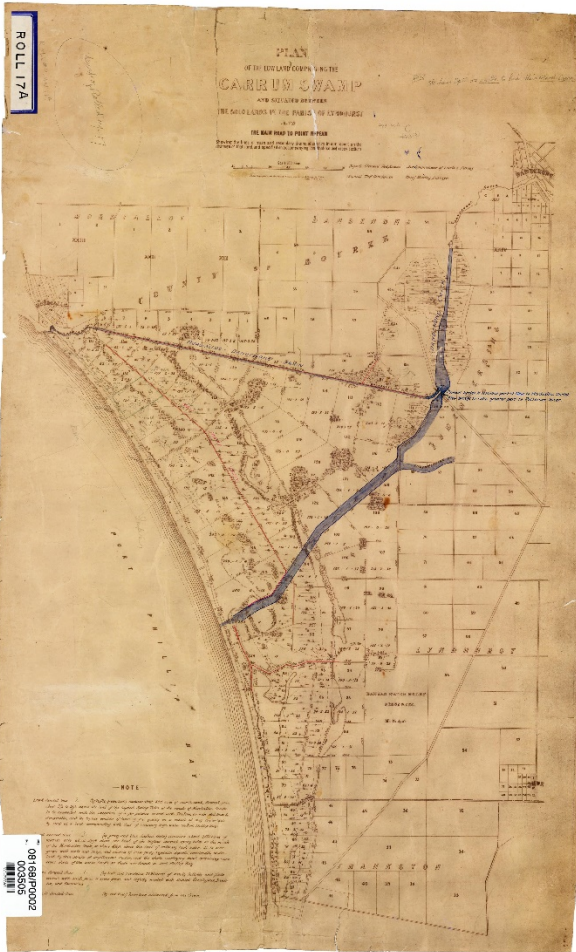
The Dandenong Creek catchment historically terminated in the Carrum Carrum Swamp, and there are multiple channels draining the swamp into Port Phillip Bay. In the late 1880s the swamp was ‘cut’ to drain the land to make it more accessible to agriculture and the Patterson River and large parts of the Mordialloc Creek were formed (Photo 8).

Photo 8. Map of the former Carrum Carrum Swamp from 1968 with an overlay of later works showing the Patterson River 'cut' and drain that forms most of Mordialloc Creek.

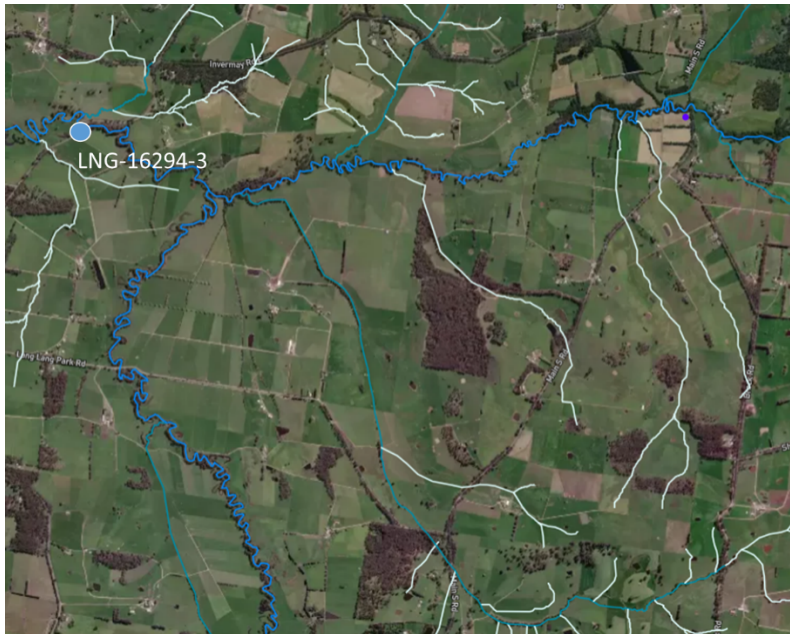
This site along the Lang Lang River is located off Drouin-Korumburra Road in Athlone (Figure 47) and was first sampled for macroinvertebrates in June 1994. It is situated within the Lang Lang River sub-catchment and is characterised as having a predominately rural land cover.

Figure 47. Aerial image of location of LNG-16294-3 Lang Lang River macroinvertebrate sampling location and its upstream catchment area. Headwaters are shown in white, tributaries in teal.

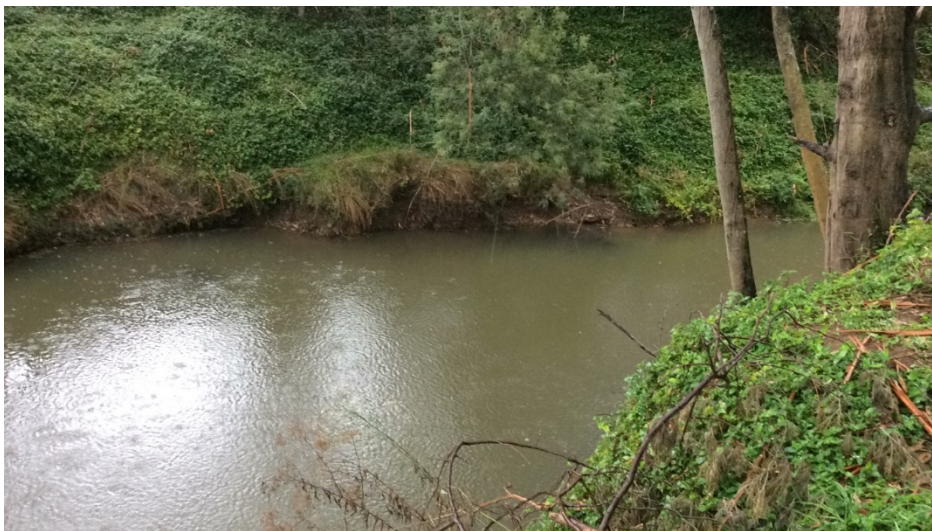
Photo 9. LNG-16294-3 Lang Lang River, Athlone (Lang Lang River sub-catchment).

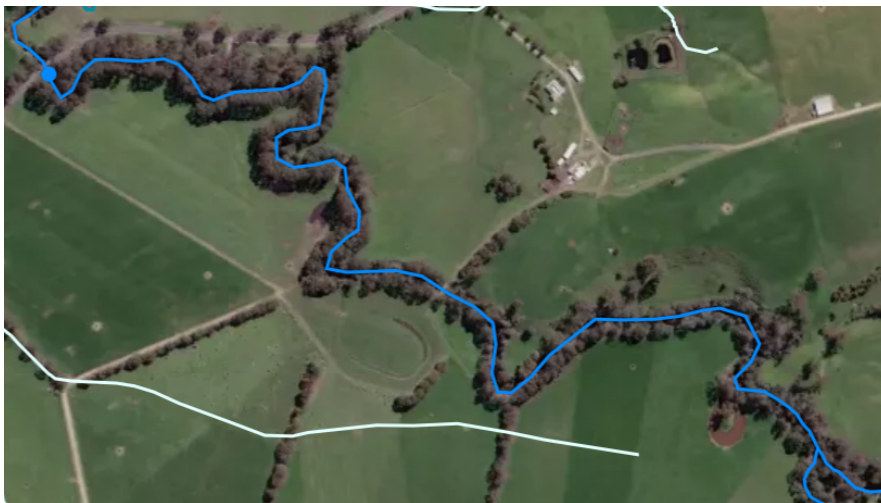
Riparian vegetation quality rating along this reach is moderate (level 3 vegetation visions)(Figure 50). Attenuated forest cover along this reach is 38.9% and has not changed between 2006 and 2016.

Figure 50. Macroinvertebrate monitoring sites location and upstream reach (aerial image is from OpenStreetMap 2021).

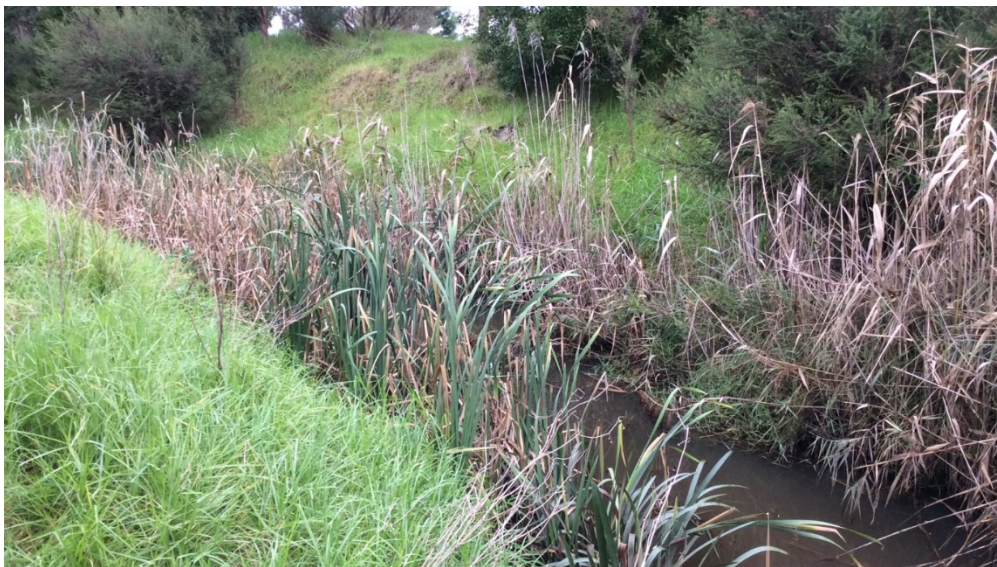
Photo 10. TOO-4334-2 Toomuc Creek, Pakenham (Cardinia, Toomuc, Deep and Ararat Creeks sub-catchment).

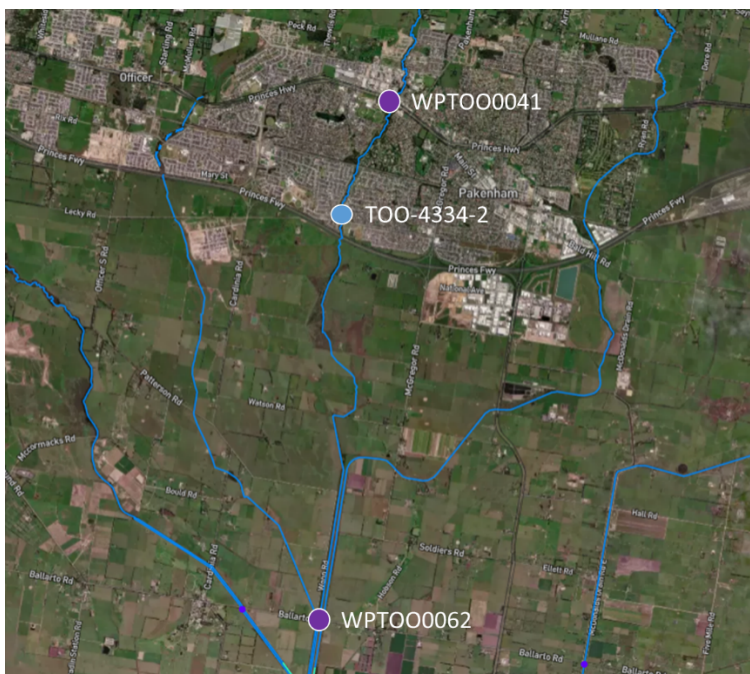
Water Quality monitoring locations are present upstream and downstream of the macroinvertebrate location that has declined over time (Figure 56).

Figure 56. Map showing relative location of Macroinvertebrate site TOO-4334-2 (in blue) and upstream and downstream water quality monitoring site WPTOO0041 and WPTOO0062 (in purple).

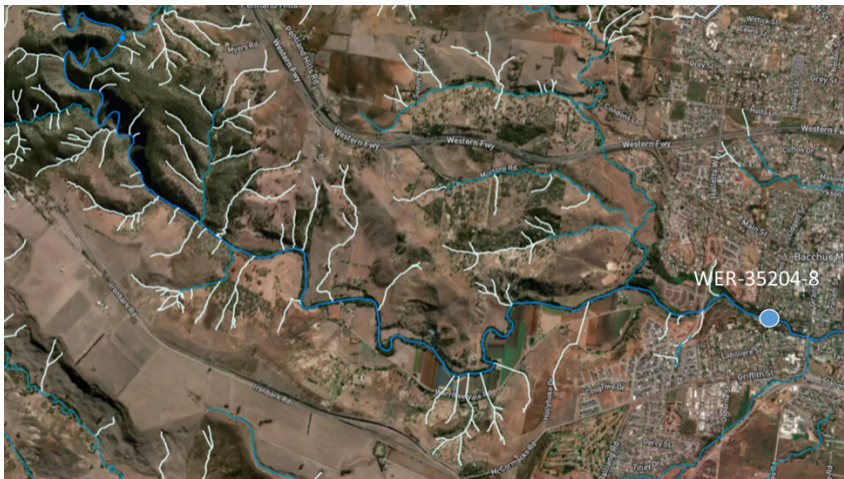
This site along the Werribee River is located at the Bacchus Marsh Gauge in Bacchus Marsh and was first sampled for macroinvertebrates in March 1995. The site has a predominately rural catchment but is located adjacent to land that is rapidly urbanizing (Figure 62).

Figure 62. Aerial image of the location of WER-35204-8 Werribee River macroinvertebrate sampling location and its upstream catchment area. Headwaters are in white, tributaries in teal, main creek in blue.

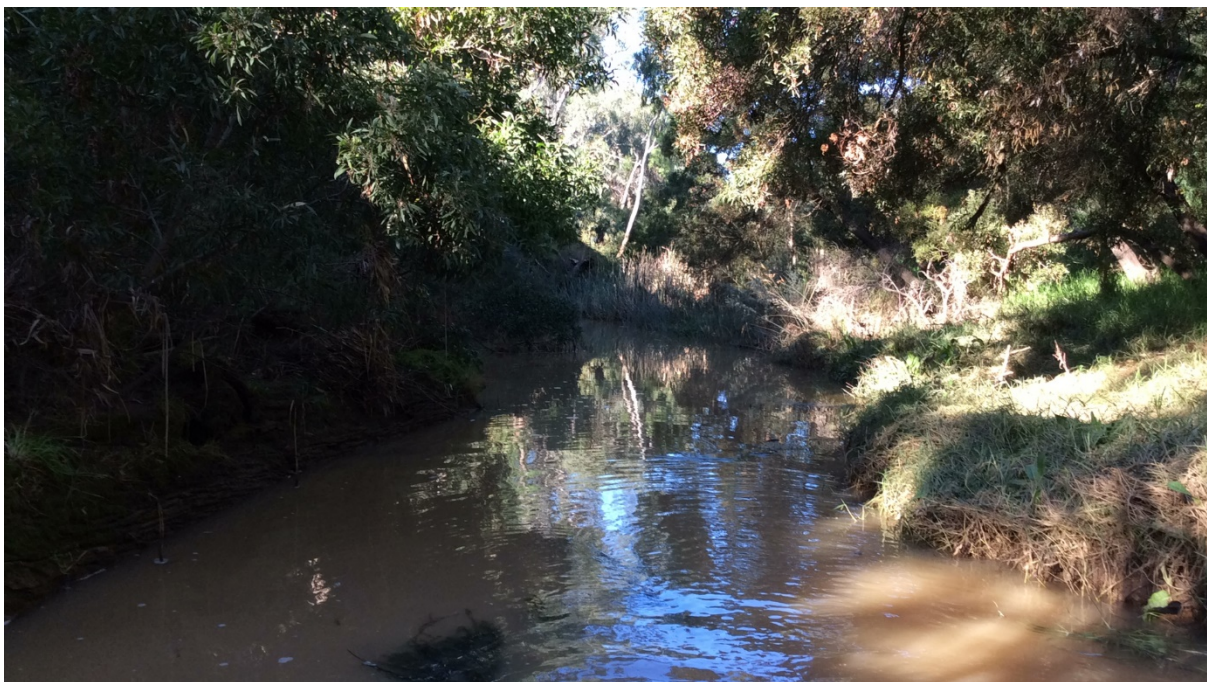
Photo 11. WER-35204-8 Werribee River at Bacchus Marsh (Werribee River Middle sub-catchment).

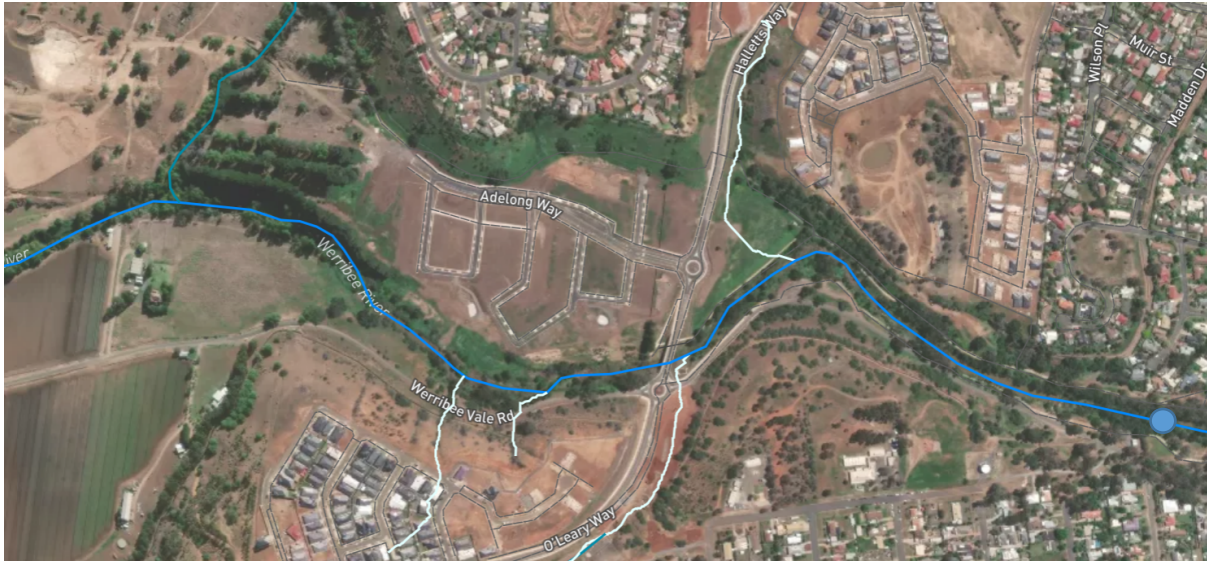
Vegetation quality is rated as low along this reach (i.e. level 2 out of 5 vegetation visions score)(Figure 66). Attenuated forest cover was 22% in 2006 with no change detected in 2016.

Figure 66. Macroinvertebrate monitoring site location and upstream reach (aerial image is from OpenStreetMap 2021 scale 1:8,000).

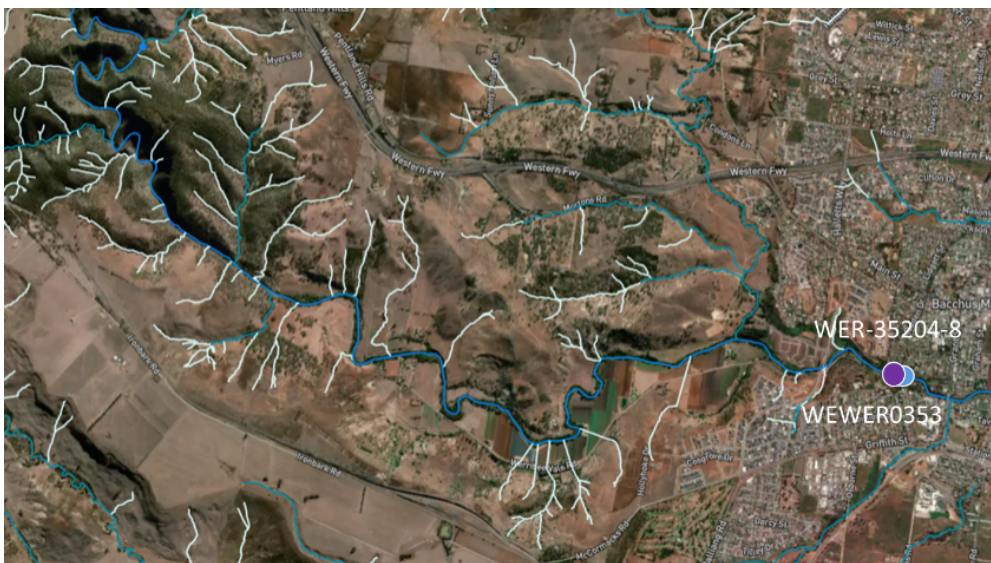
There is an overlap between the long-term water quality monitoring and the macroinvertebrate monitoring site in this location (Figure 67).

Figure 67. Map of Werribee River catchment area depicting the location of macroinvertebrate and water quality monitoring locations.

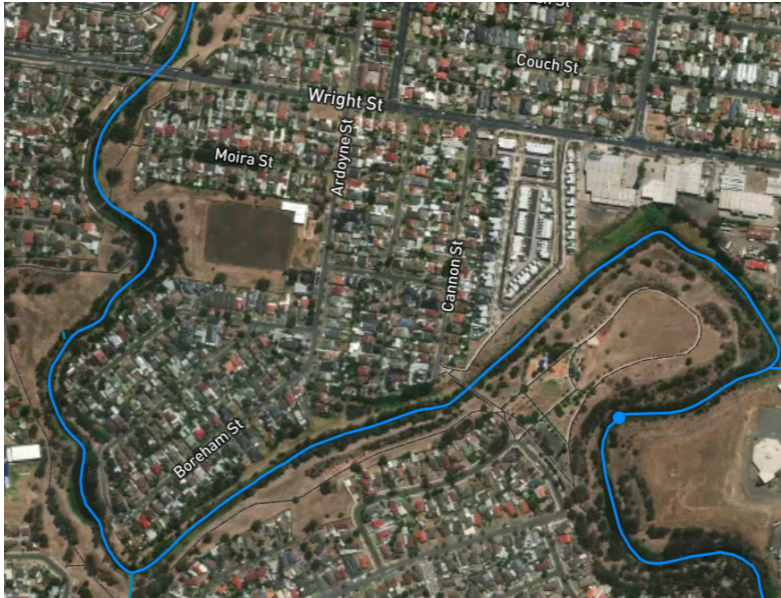
Vegetation quality is rated as low (level 2 vegetation visions score) (Figure 73). This is the only site where trends have been assessed where attenuated forest cover has increased between 2006 and 2016 from 10% to 14%.

Figure 73. Macroinvertebrate monitoring site location and upstream reach (aerial image is from OpenStreetMap 2021).

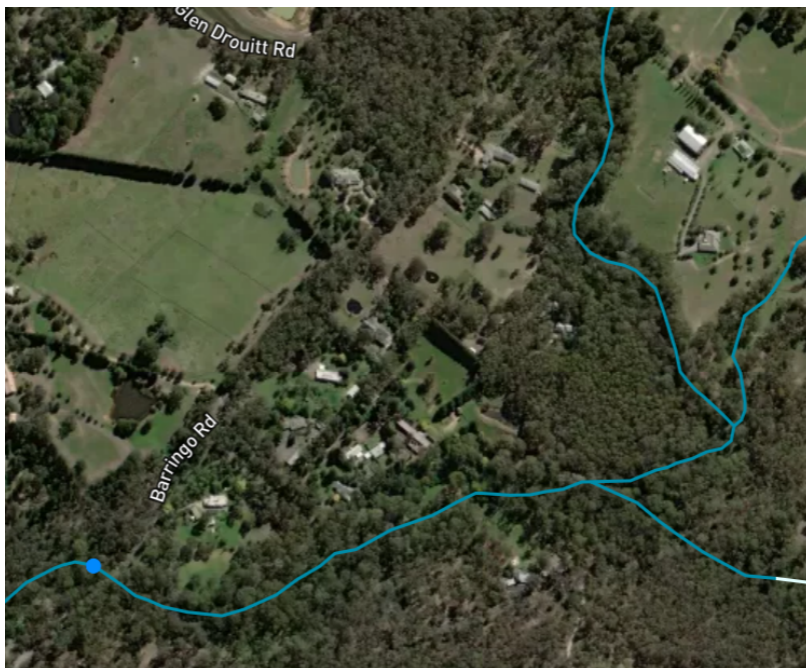
Vegetation quality is rated as very high (vegetation visions score of 5)(Figure 77)along this reach, although the confidence in this rating is low. In 2016, attenuated forest cover along this reach was 87.2% with no change detected from the earlier data in 2006.

Figure 77. Macroinvertebrate monitoring site location and upstream reach (aerial image is from OpenStreetMap 2021).

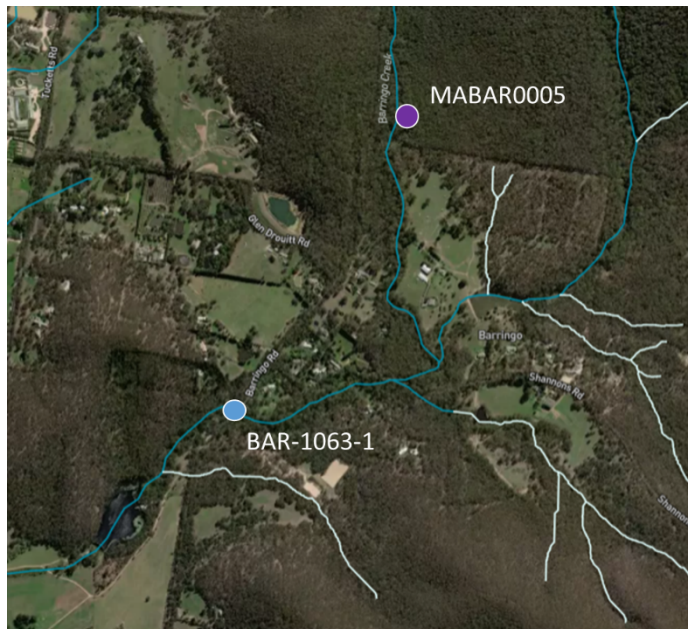
There is a long-term water quality monitoring location nearby (Figure 78 but it has a forested upstream catchment area, so is not considered useful to help determine the causes of decline at the macroinvertebrate site.)

Figure 78. Map of Barringo creek catchment area depicting the location of macroinvertebrate and water quality monitoring locations.

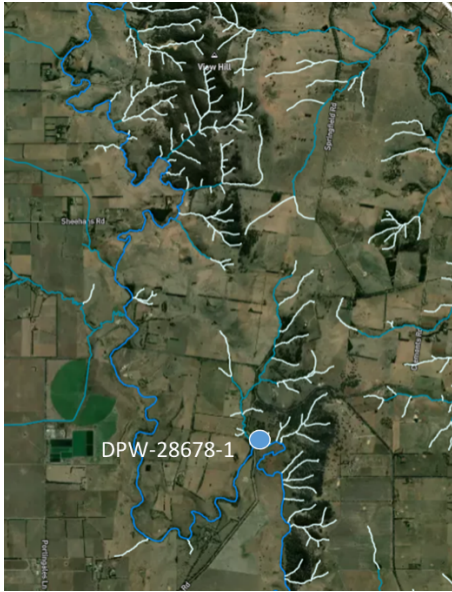
Deep Creek (Trib of Maribyrnong) is located ~80m downstream of Joyces Road and is within the Deep Creek Upper sub-catchment (Figure 79). The site was first sampled for macroinvertebrates in November 1994 and has a rural land cover.

Figure 79. Aerial image of location of DPW-2868-1 Deep Creek macroinvertebrate sampling location and its upstream catchment area. Headwaters in white, tributaries in teal, main creek in blue.

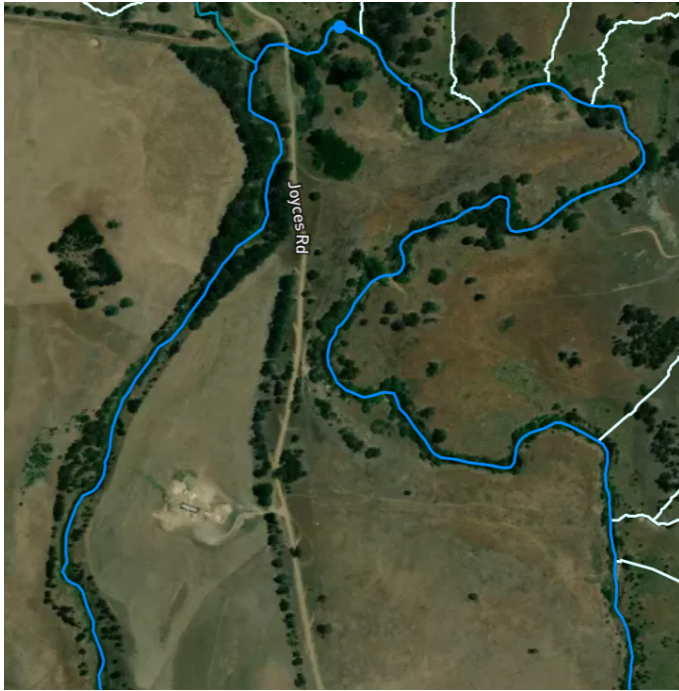
Vegetation quality is rated as medium along this reach (vegetation vision score of 3 out of 5) (Figure 81). Attenuated forest cover along this reach was 21.4% in 2006 and 2016.

Figure 81. Macroinvertebrate monitoring site location and upstream reach (aerial image is from OpenStreetMap 2021).
