# Macroinvertebrates

A Technical Report to inform the  
Healthy Waterways Strategy Mid-term Review

Melbourne Water (2023), *Macroinvertebrates: A Technical Report to inform the Healthy Waterways Strategy Mid-term Review*. Melbourne Water, Docklands, Victoria, Australia.

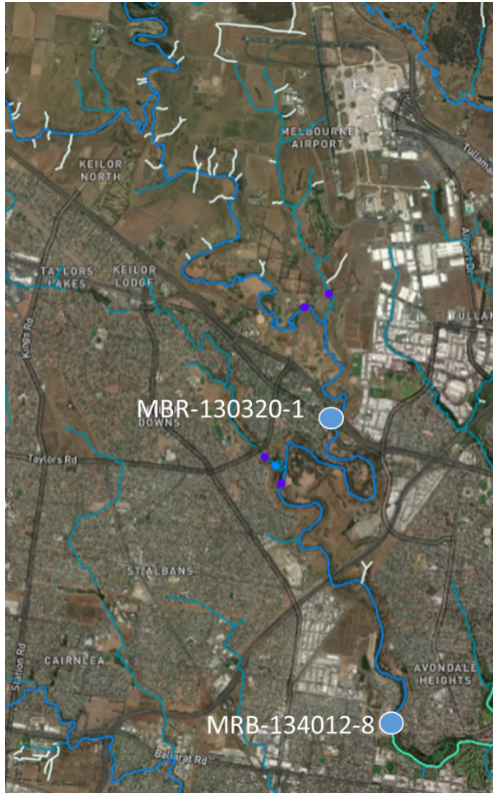
These two sites are located on the main stem of the Maribyrnong River. MRB-130320-1 is located at Flora Street, Keilor, downstream of the Calder Freeway bridge. MRB-134012-8 is located at Solomon's Ford, Canning Street, Avondale Heights, and is the last riffle on the Maribyrnong before the river becomes estuarine-influenced (Figure 84). Both sites were first sampled for macroinvertebrates in June 1994.

Figure 84. Aerial image of location of MBR-130320-1 and MBR-134012-8 Maribyrnong River macroinvertebrate sampling location and its upstream catchment area. Headwaters in white, tributaries in teal, main creek in blue.

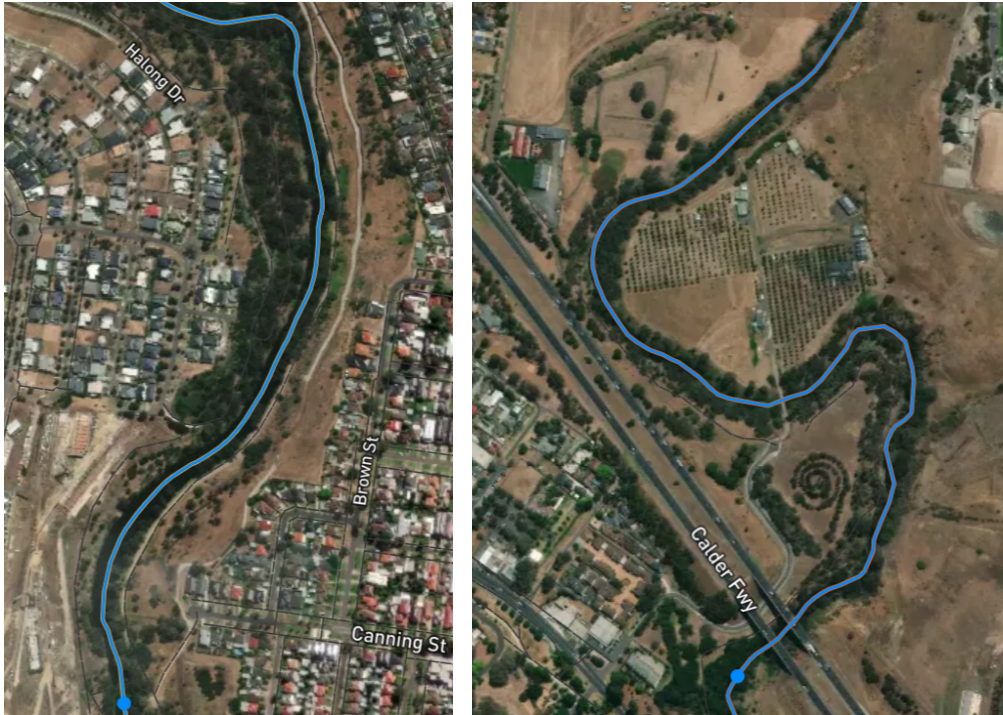
Vegetation quality at MRB-134012-8 (left) is medium (ie vegetation vision 3 out of 5) while the rating at MRB-130320-1 (right) is low (2 out of 5) (Figure 89). Attenuated forest cover was 30% in 2006 and 2016 at MRB-130320-1 and 34.6% in 2006 and 2016 at MRB-134012-8.

Figure 89. Macroinvertebrate monitoring sites location and upstream reach MRB-134012-8 (left) MRB-130320-1 (right) (aerial image is from OpenStreetMap 2021 – scale 1:8,000).
